**Industrial Area and Buffer Zone  
Sampling and Analysis Plan  
Modification 1**

**May 2004**

The Industrial Area (IA) and Buffer Zone (BZ) Sampling and Analysis Plan (SAP) (IABZSAP) describes surface and subsurface soil characterization and remediation confirmation sampling activities for Individual Hazardous Substance Sites (IHSSs), Potential Areas of Concern (PACs), and Under Building Contamination (UBC) Sites at the Rocky Flats Environmental Technology Site (RFETS). It is the Rocky Flats Cleanup Agreement (RFCA) decision document for accelerated action sampling in the IA and BZ.

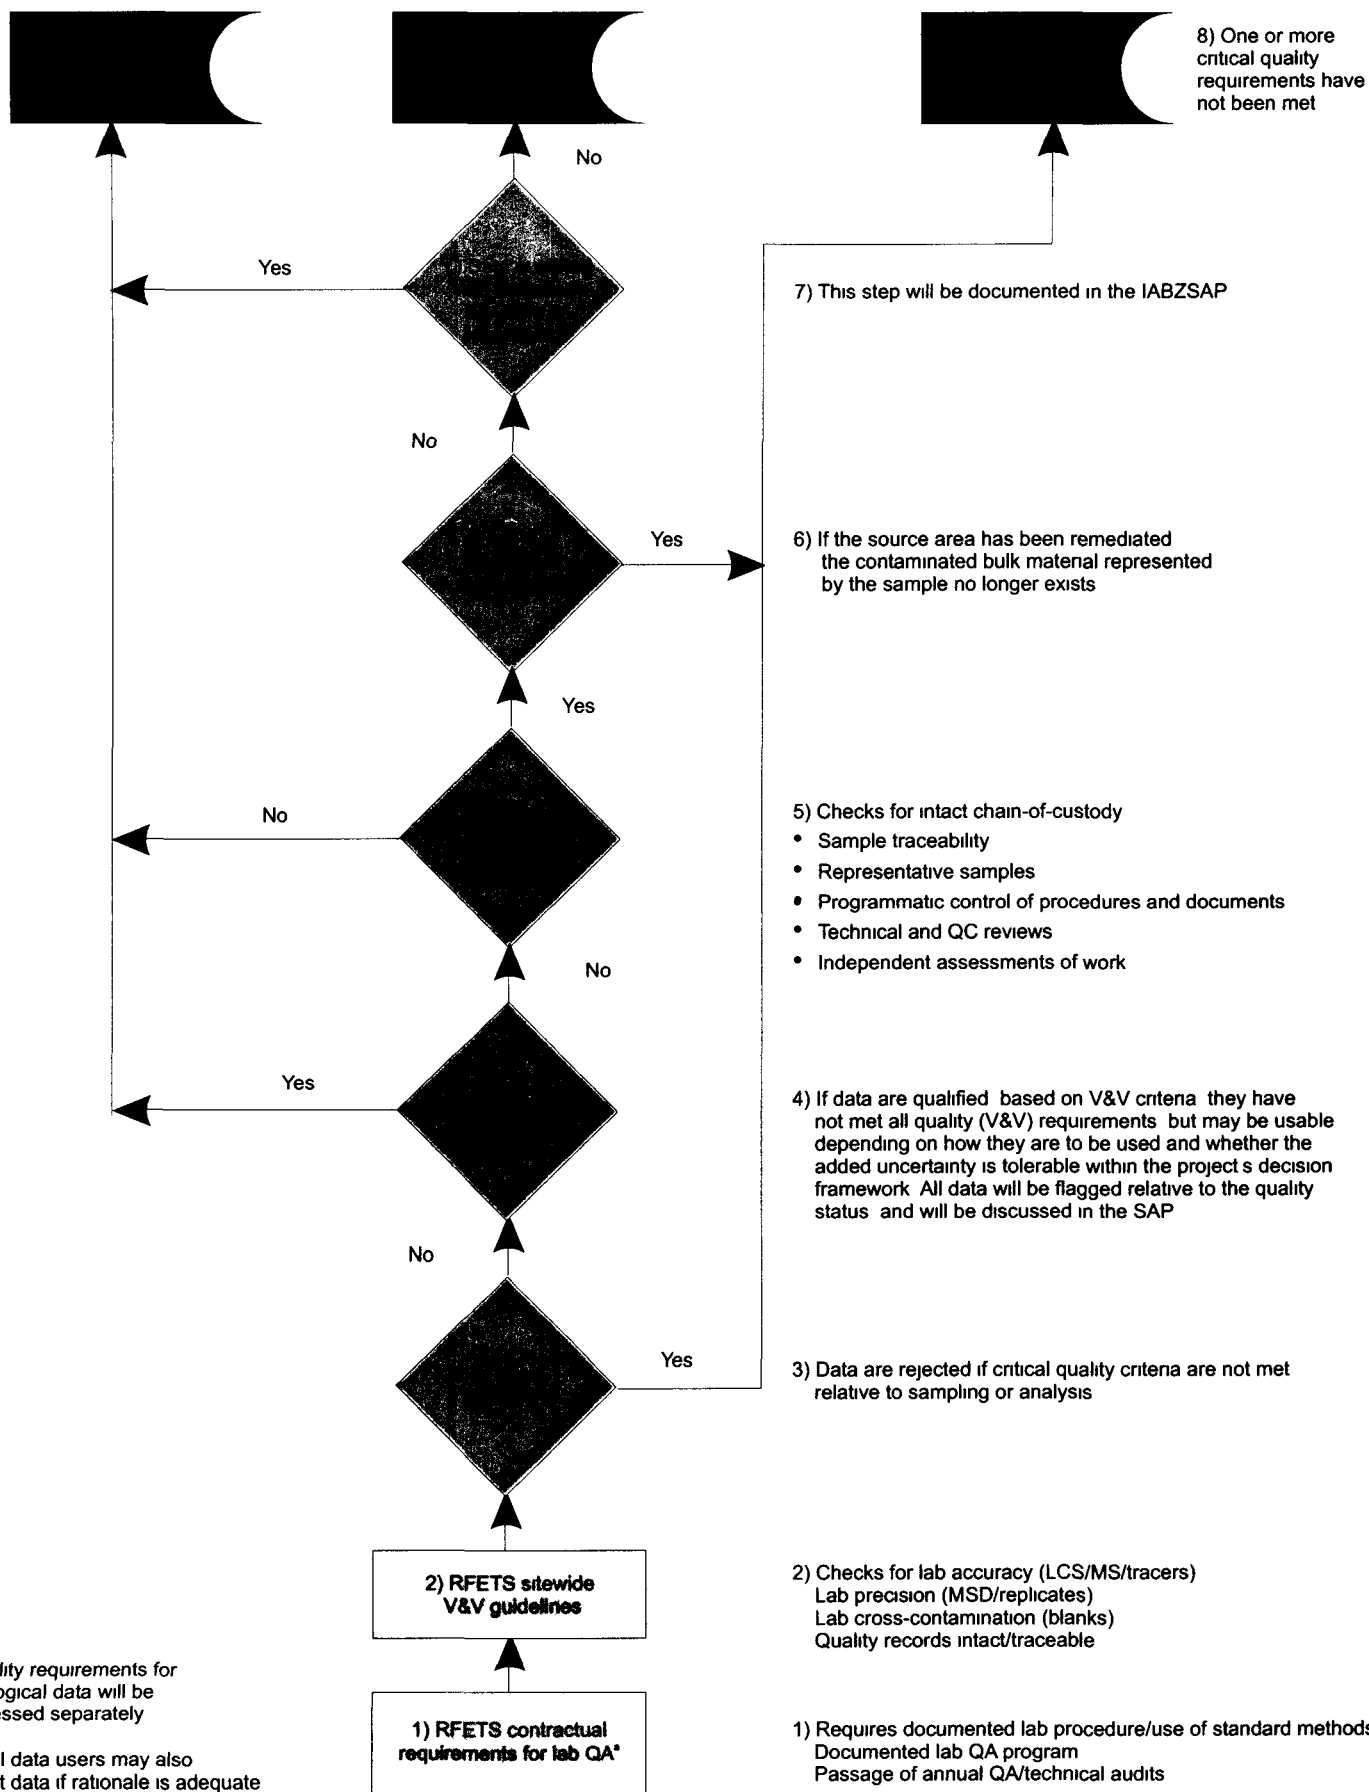
**Figure 20**  
**Data Quality Filter for the Industrial Area and Buffer Zone Sampling**  
**and Analysis Plan**

- 1 If all analytical results for organic compound PCOCs or COCs are nondetections, the compounds will be disqualified from further consideration; otherwise, the compounds will be retained. AOCs will be determined based on organic PCOC or COC concentrations above MDLs for existing data or RLs for accelerated action data.
- 2 If all data values for inorganic and radionuclide PCOCs or COCs are less than the background means plus two standard deviations, the inorganic or radionuclide PCOC or COC will be disqualified from further consideration. Some inorganic and radionuclide concentrations may be below background levels but greater than RFCA ALs. Data values less than background will not be carried over for further evaluation. AOCs will be determined based on metal and radionuclide PCOC concentrations detected above background.

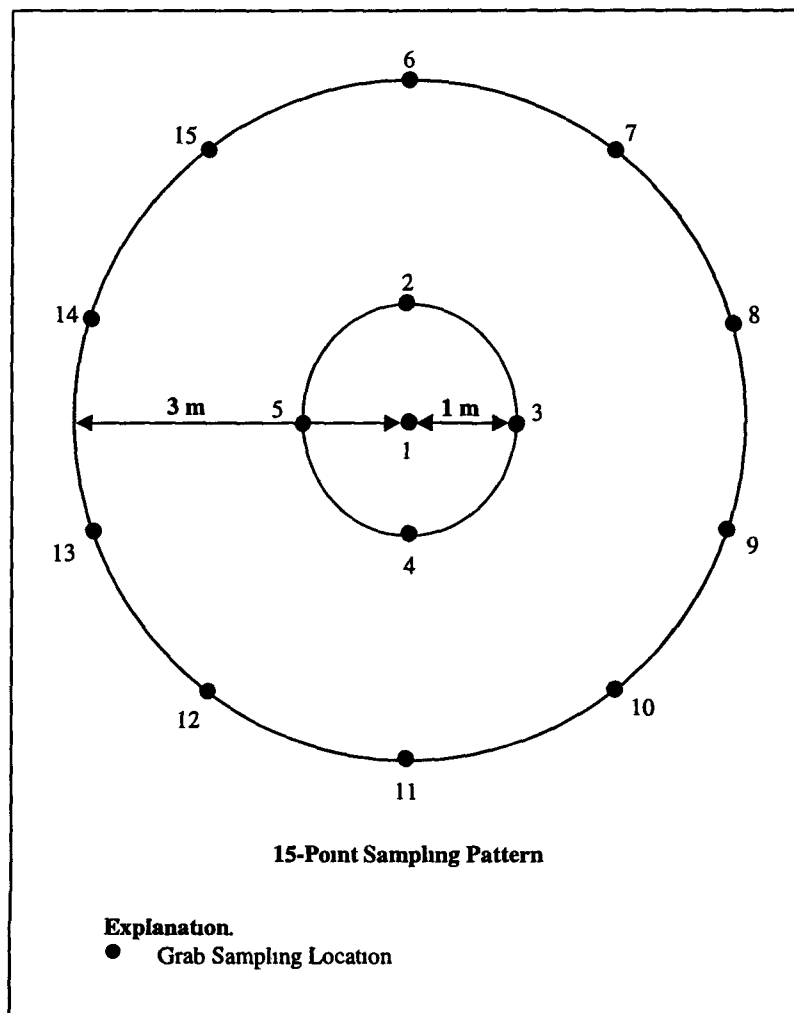
**Figure I2**  
**HPGe 15-Point Surface Soil Sampling Pattern**

Fifteen grab samples were then collected at each duplicate sampling location. 1 grab sample from the center, 4 grab samples collected at a 1-m radius, and 10 grab samples from a 3-m radius. Figure I2 provides this surface soil sampling geometry, which was developed by the U.S. Department of Energy (DOE) at the Fernald Environmental Management Project site in Ohio to correlate HPGe results to surface soil results (DOE 1997). The 1-m and 3-m radius grab samples were then composited into a 1-m and 3-m sample representative of each individual band. Therefore, three separate alpha (and gamma) spectroscopy analyses were performed at each duplicate sampling location. Samples were collected in this "bulls eye" pattern to mimic the averaging done by the field HPGe detector over the instrument's FOV. The HPGe detector receives gamma ray photons from every point within the circle, however, it receives more gamma rays from soil closer to the detector than from soil farther from the detector. If the circle is divided into concentric bands, the relative weighting factor for each band can be calculated based upon the percentage of influence of gamma photons at the detector which originates from a given band of soil, assuming a uniform source distribution with depth and a 1 value of energy (MeV) photon energy. The relative weighting factor is the relative importance of each band with respect to the probability of gamma rays emitted from within that band being detected by the HPGe.

The sample results were multiplied by the weighting factor per band, then the products were summed to determine the activity of the soil in the FOV area. It should be noted that these results were adjusted for moisture content in order to report results on a wet weight or "in situ moisture" basis. At every duplicate sampling location, the "real" and "duplicate" data were averaged (denoted as "combined"), and the "combined" data were used in the weighted averaging process to develop the data for the correlation.

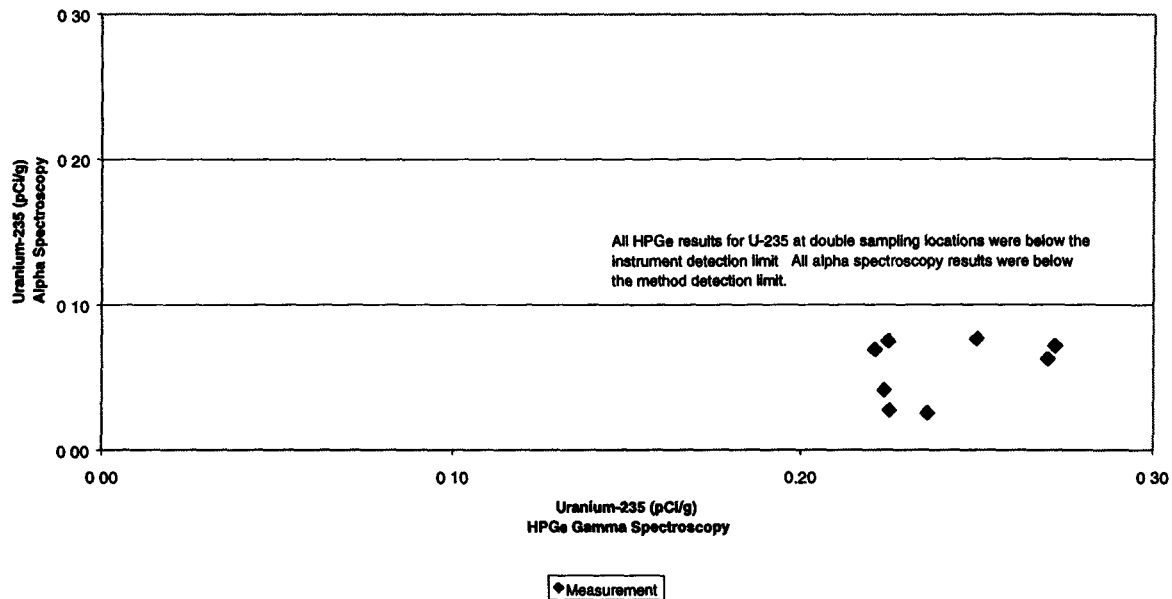
**Figure I5**  
**Minimum Detectable Activities U-235**

As shown in Figures I5 and I6, correlations for the alpha spectroscopy/HPGe data for U-235 and U-238 were not performed because in both cases the U isotopes were not detected by in-situ HPGe. The plots show minimum detectable activities when the isotopes were nondetect ions. Also, alpha spectroscopy did not measure detectable levels of U-235, and only in a few instances was U-238 detected at estimated activities. Therefore, U-235 and U-238 results derived from the HPGe survey were used directly as the surface soil radiological data for these isotopes (i.e., values were not standardized to laboratory alpha spectroscopy measurements). The lack of correlation for the U data does not impact the findings reported in the 903 Pad Characterization Report (Kaiser-Hill 2000), because the activities for U isotopes are well below the ALs throughout the investigation area.

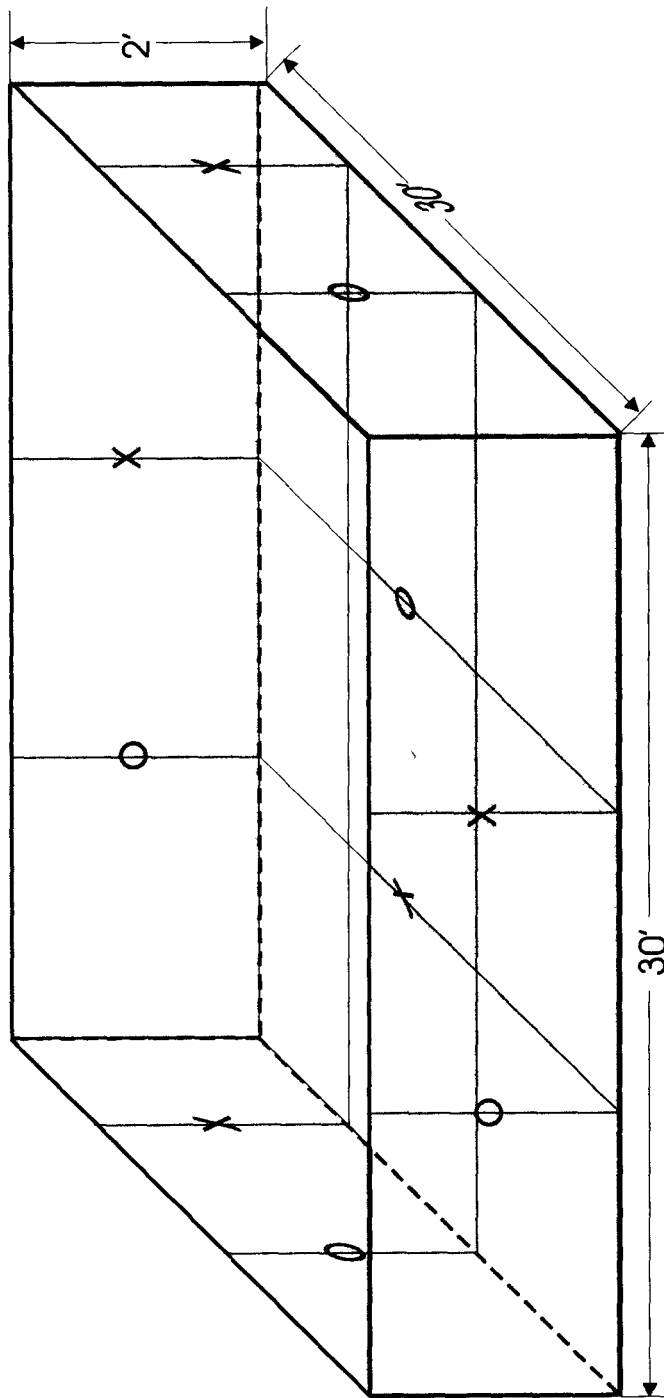
# Map 6 HCB > WRW AL Remedial Area With Confirmation Samples

X = Field Analytical Sample Collection Point  
 O = Analytical Sample Collection Point

900 Sq. Ft. Area  
 1,800 ft<sup>3</sup> Soil Removal

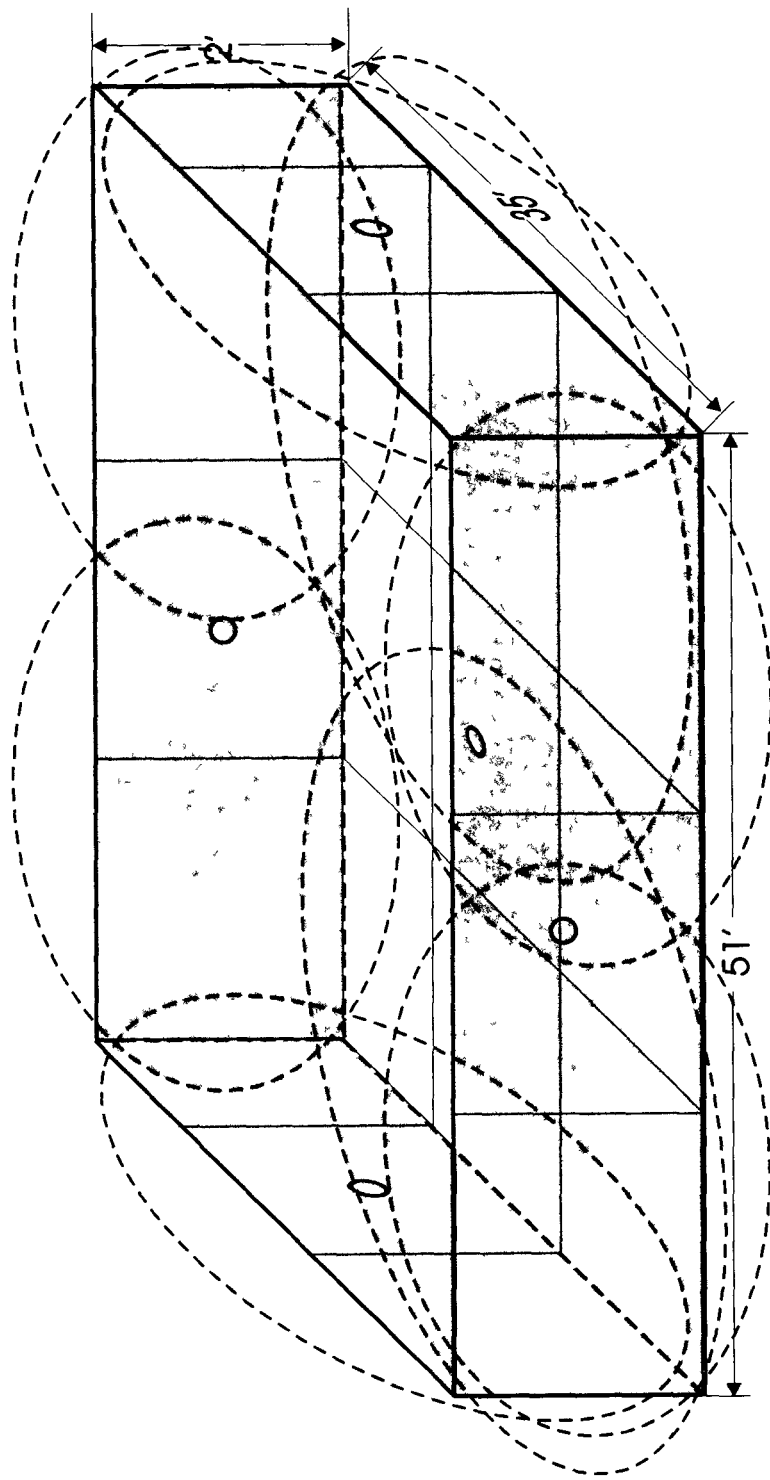
## Pu > WRW AL Remedial Area

1785 Sq. Ft. Area  
3570 ft<sup>3</sup> Soil Removal

= HPGe Sample Location  
O = Analytical Sample Collection Point

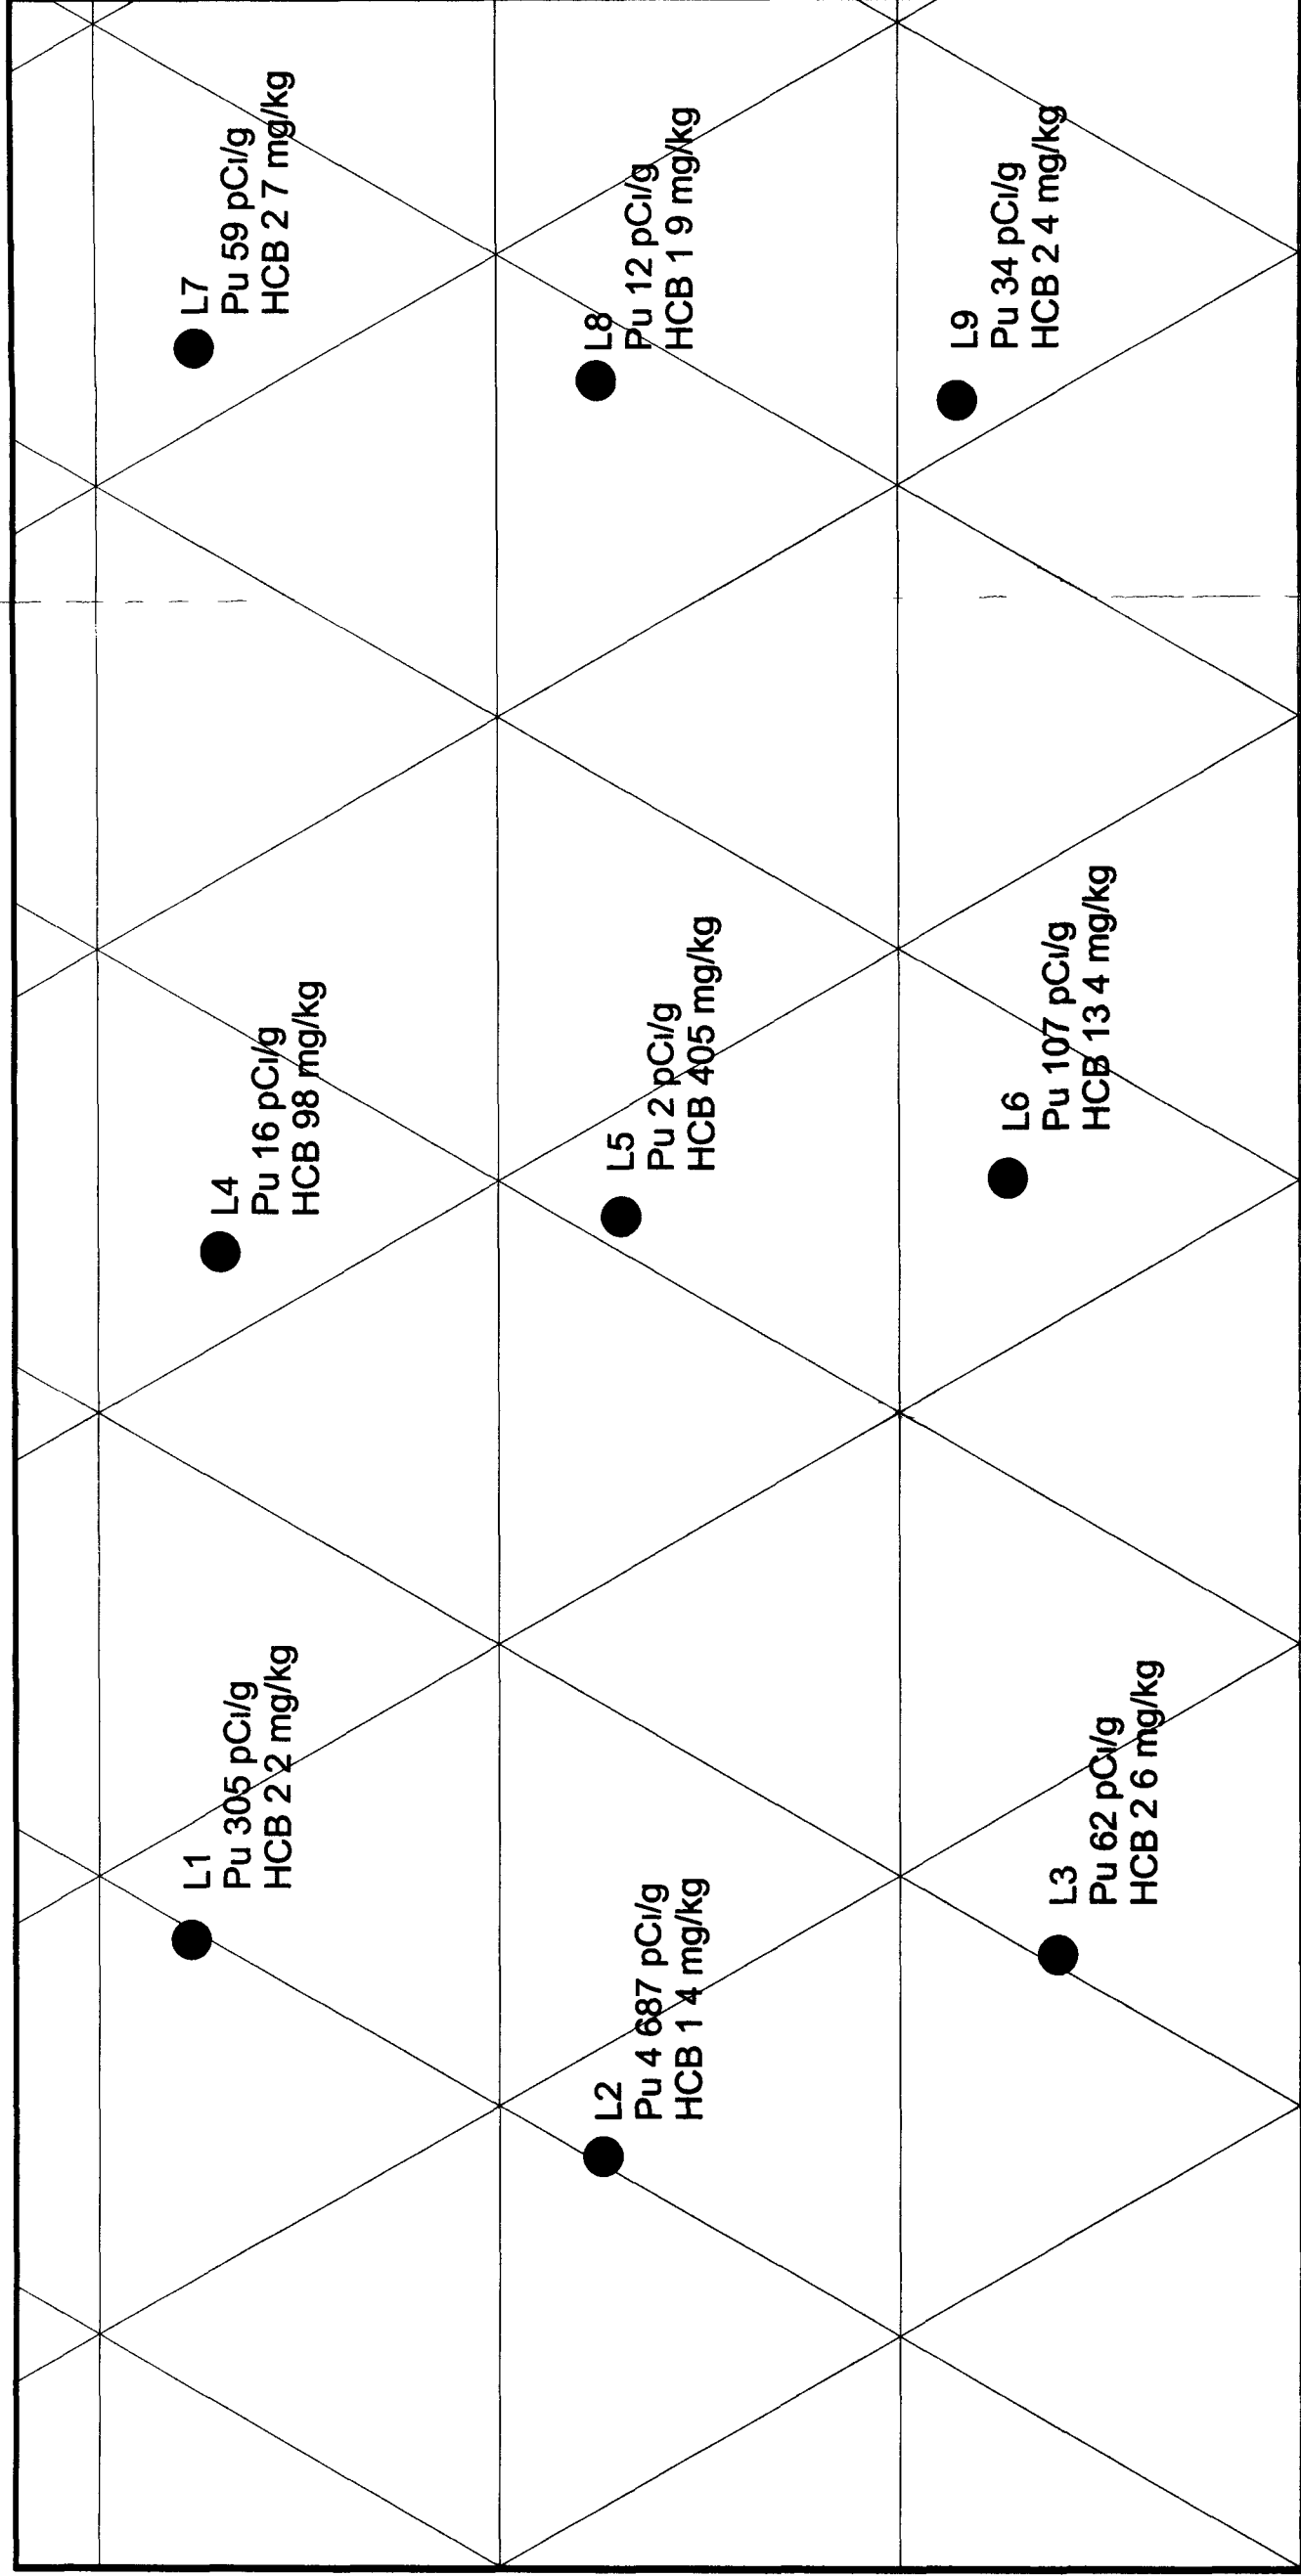
Map 2 Triangular Grid Superimposed Over IHSS Using a Random Start

Grid Spacing = 36 Feet
